**AFRL-PR-WP-TR-2001-2024**

**ANALYSIS OF SIMULATED AIRCRAFT  
LIGHTNING STRIKES AND THEIR  
ELECTROMAGNETIC EFFECTS**

**FINAL REPORT FOR PERIOD JULY 1995 - JULY 1997**

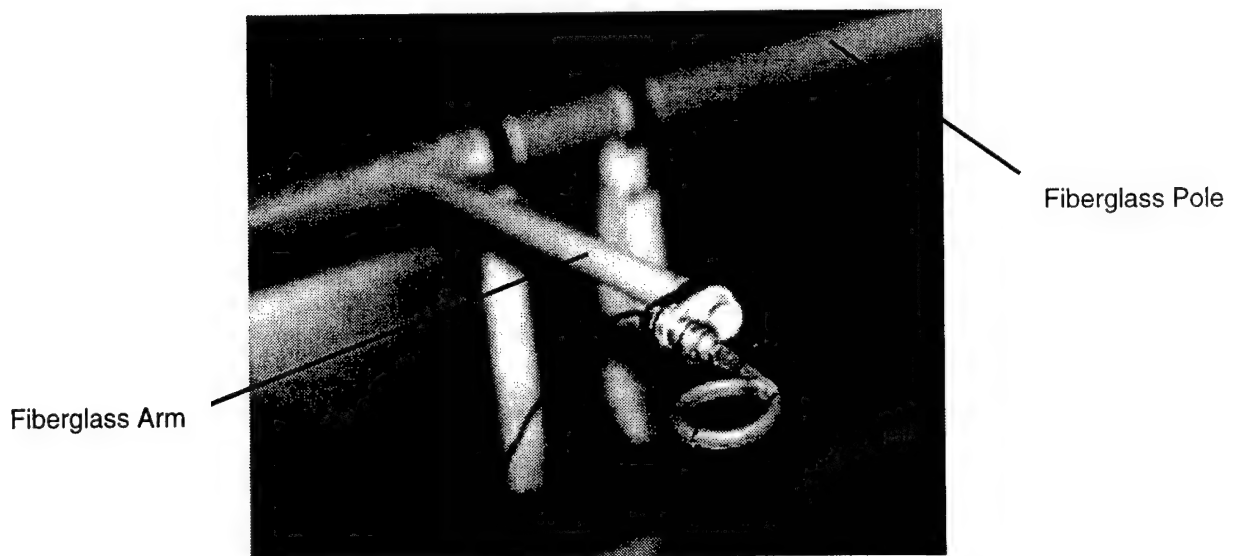
**Figure 5.** Magnetic Field Loop Sensor

The primary reason for conducting these simulated lightning strike tests was to track and record the resulting magnetic fields at different locations inside the aluminum cylinder as the current pulse from the capacitor bank traveled down the length of the simulated aircraft fuselage. Since the magnetic fields of primary concern were internal to the “closed” cylinder, a scheme was devised to locate a magnetic field loop sensor at various positions within the cylinder.

The scheme consisted of a long fiberglass pole running through the center axis of the cylinder with internal bearing supports appropriately spaced along the pole’s length. Perpendicular to the pole was a smaller fiberglass arm that was used to mount the magnetic field loop sensor (Figure 5). Since the centrally located pole protruded through the ends of the cylinder, it could be rotated to obtain various angular positions for the sensor. It could also be moved along the axis of the cylinder to obtain various axial sensor positions. The location of the sensor on the smaller arm provided a range of radial positions as well. This sensor-positioning scheme enabled magnetic field “mapping” inside the cylinder where panels had been removed or reconfigured. It also saved a considerable amount of time when repositioning the sensor since the panels, which each had 38 screws fastening them to the cylinder, did not have to be unscrewed and then re-screwed into the cylinder each time the sensor needed to be repositioned.

To better understand the analysis, it should be noted that the magnetic field loop sensor's active plane is parallel to the cylinder's radius (Figure 5). Therefore, magnetic flux *parallel* to this plane does not generate a signal. The sensor's "directionally dependent" signal only measures flux with a vector component orthogonal to its "active" plane. The fact that the sensor's signal may go to "zero" or change polarity implies nothing about the resultant magnitude of the total magnetic field, just the component that is normal to its "active" plane. [3]
